EGG-2683  
December 1992

# Final Report of the Decontamination and Decommissioning of the BORAX-V Facility Turbine Building

**Idaho National Engineering Laboratory  
EG&G Idaho, Inc.  
Idaho Falls, Idaho 83415**

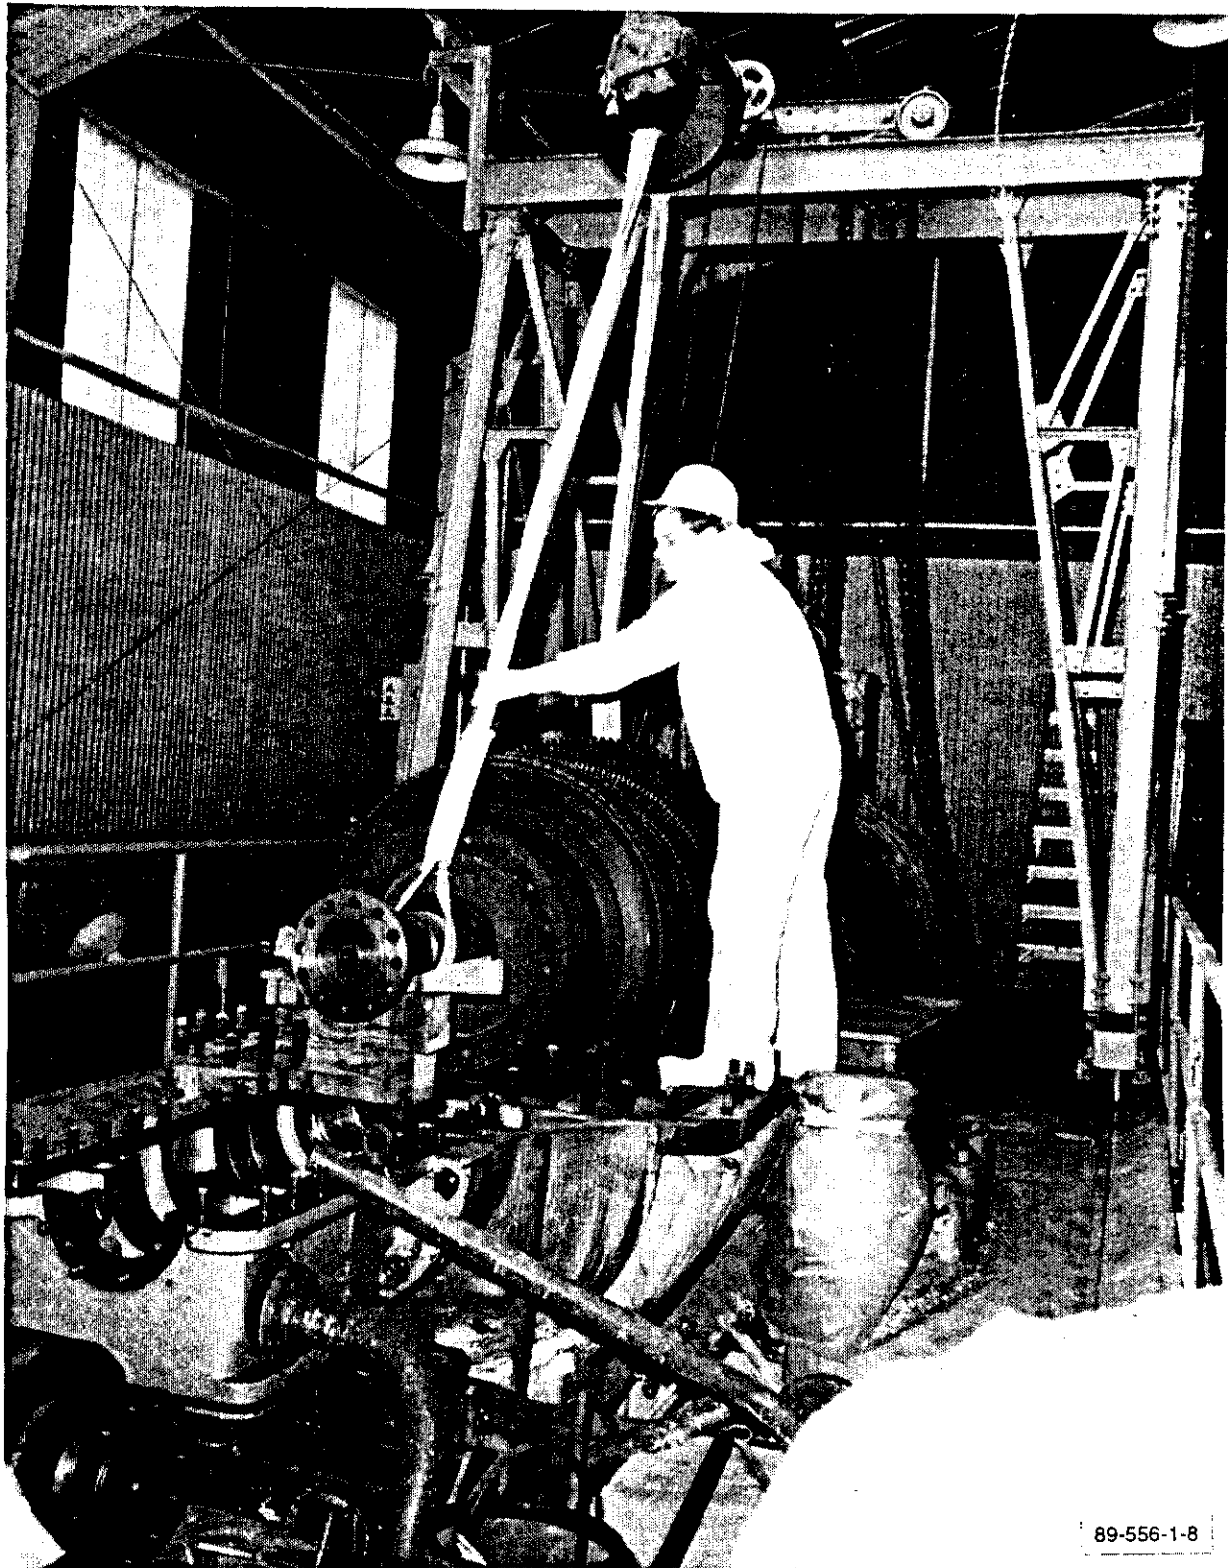
**Figure 11.** Disassembly of steam turbine assembly.

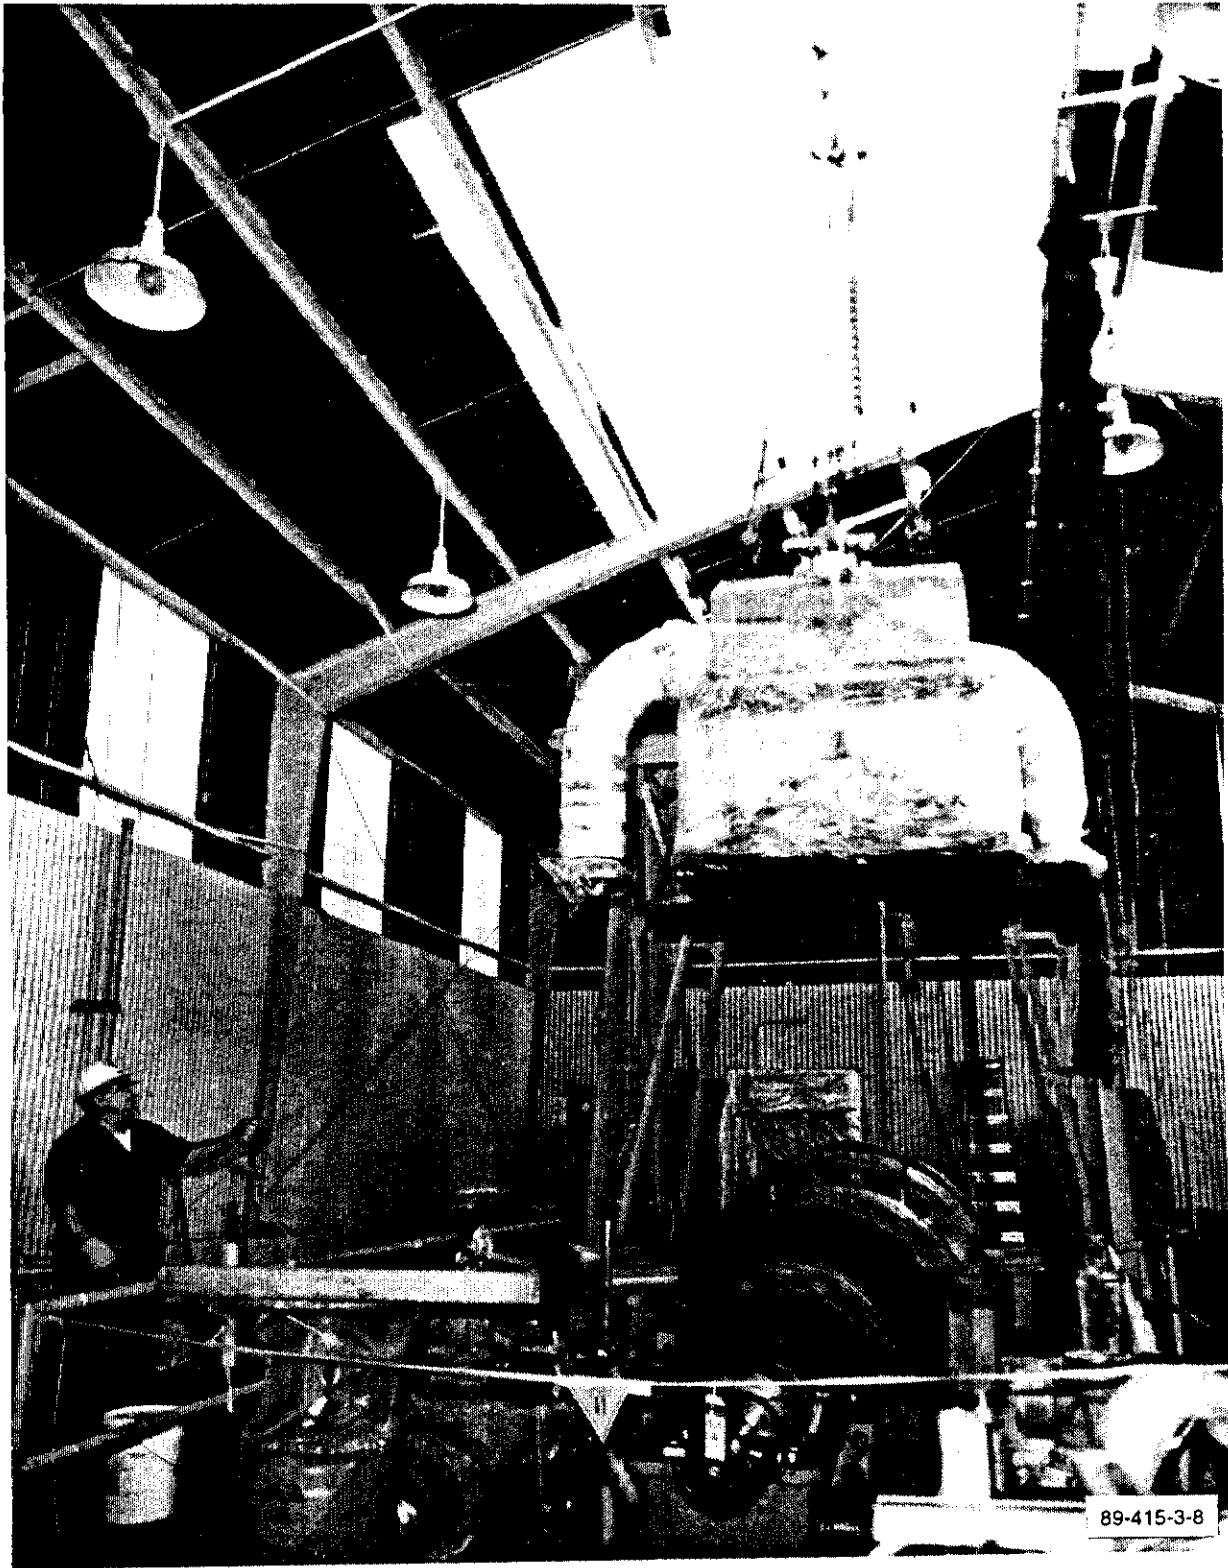
**Figure 12.** Removal of the steam turbine upper casing from the turbine building.

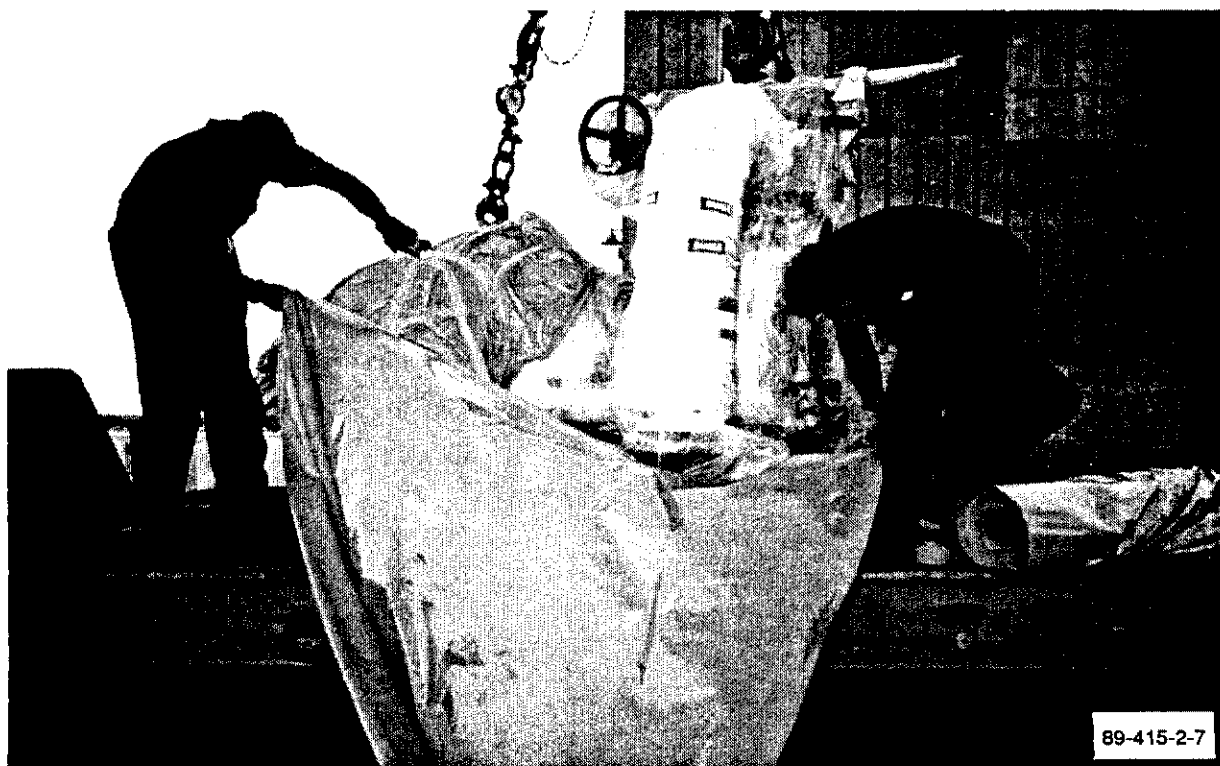
**Figure 13.** Preparing the steam turbine upper casing for shipment to RWMC.

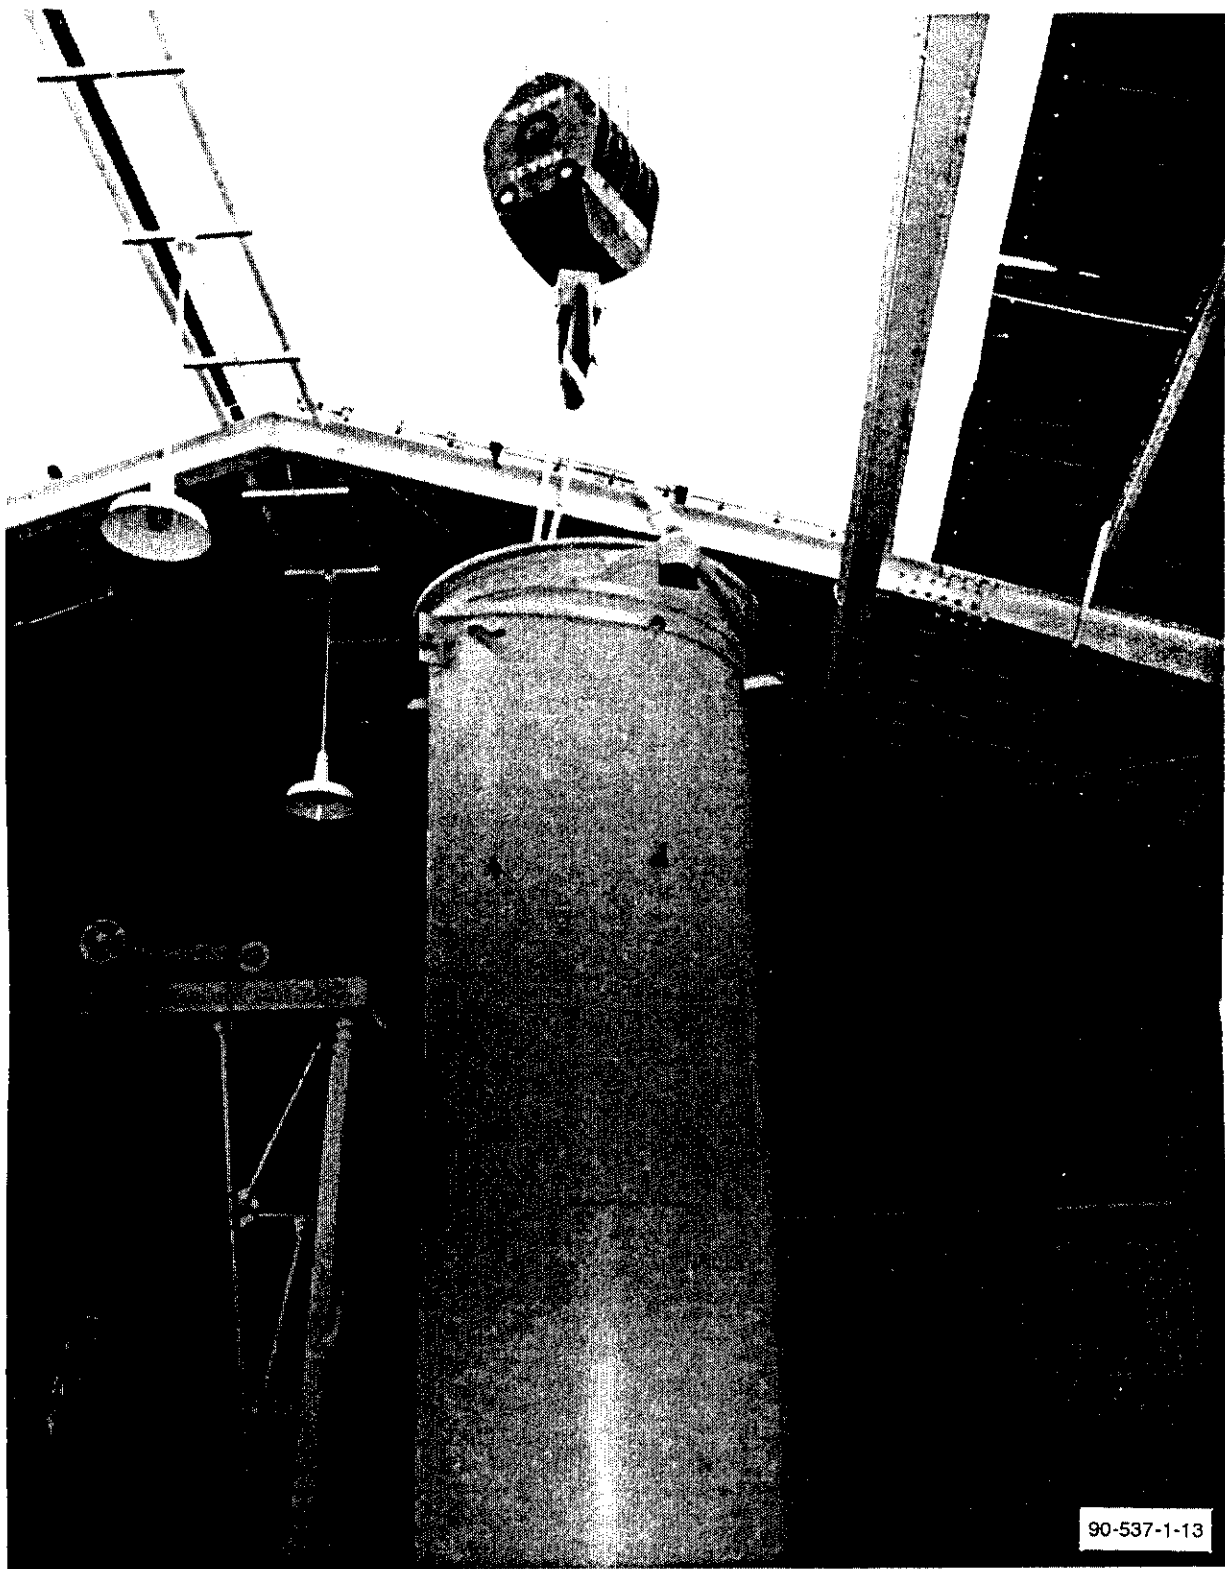
**Figure 14.** Removal of the pink tank from turbine building.

**Pink Tank.** The pink tank (see Figure 5, Item Number 29) was torch cut from its mounting brackets and lifted through an opening in the roof (see Figure 14). The tank was radiologically clean and was transported to the CFA excess yard for salvage.

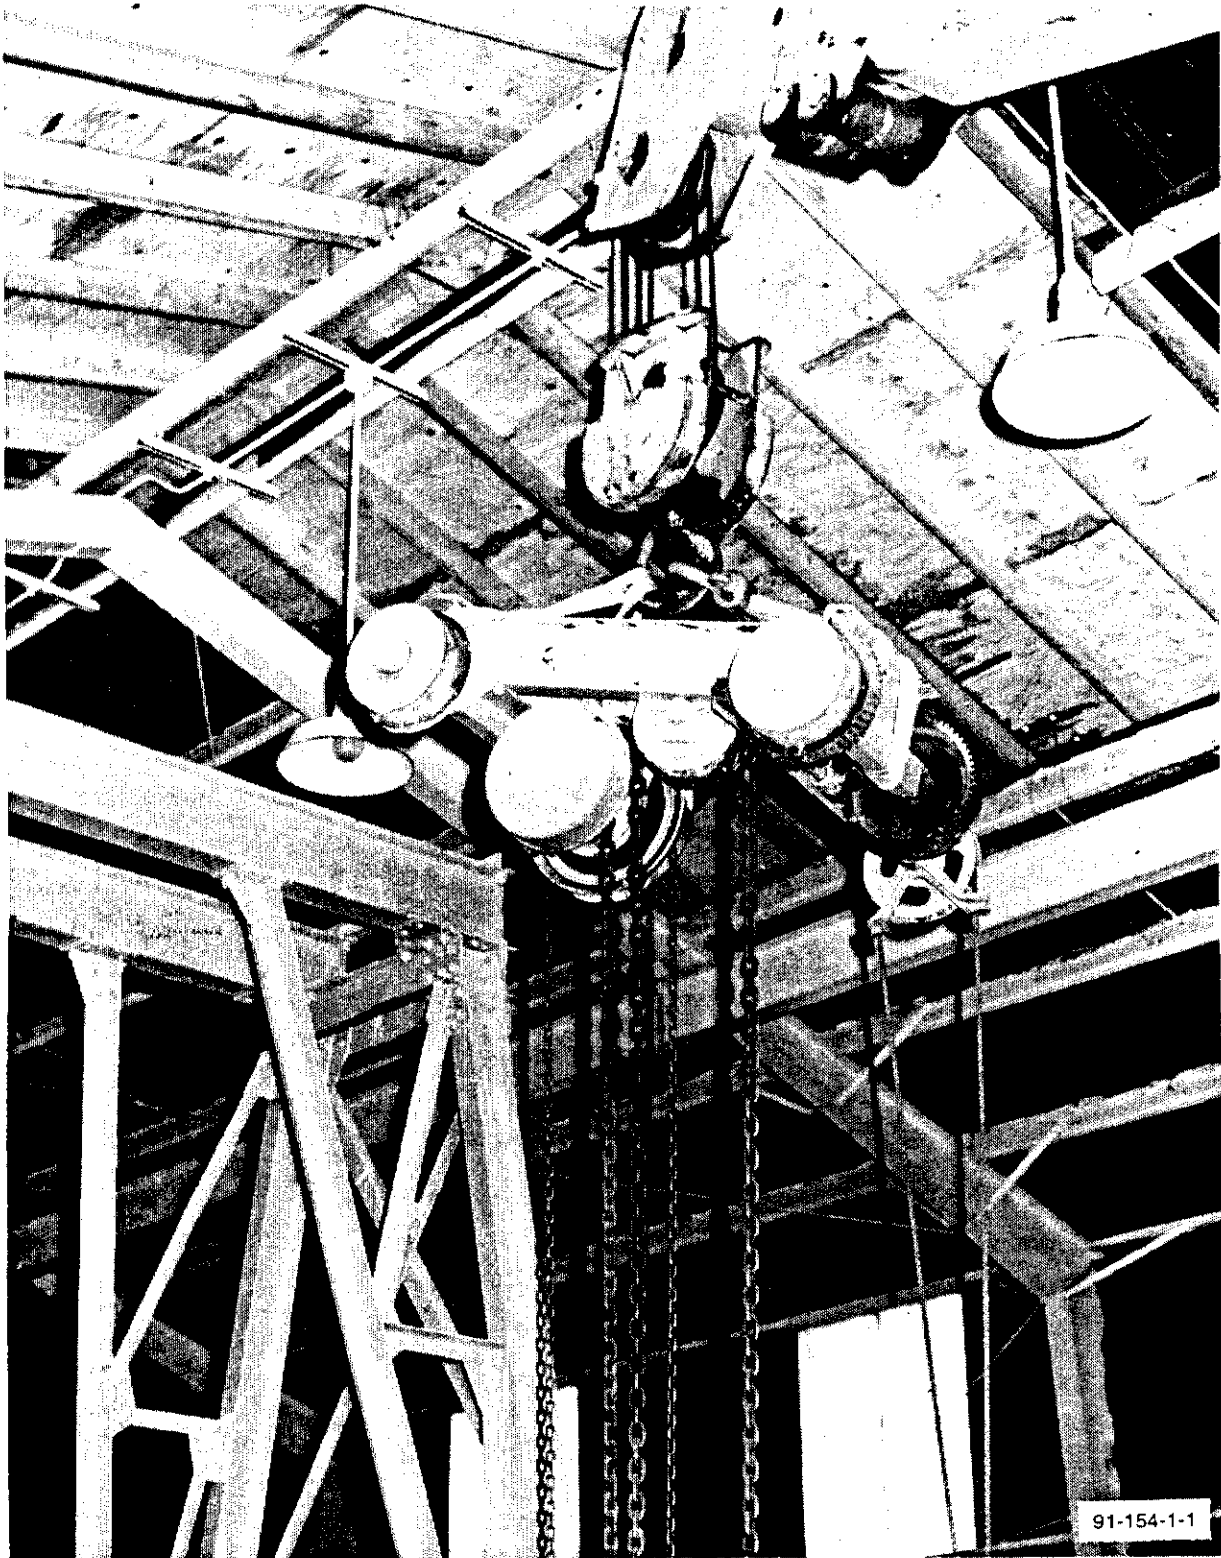
**Figure 15.** Disassembly of the 10-ton maintenance rail crane.

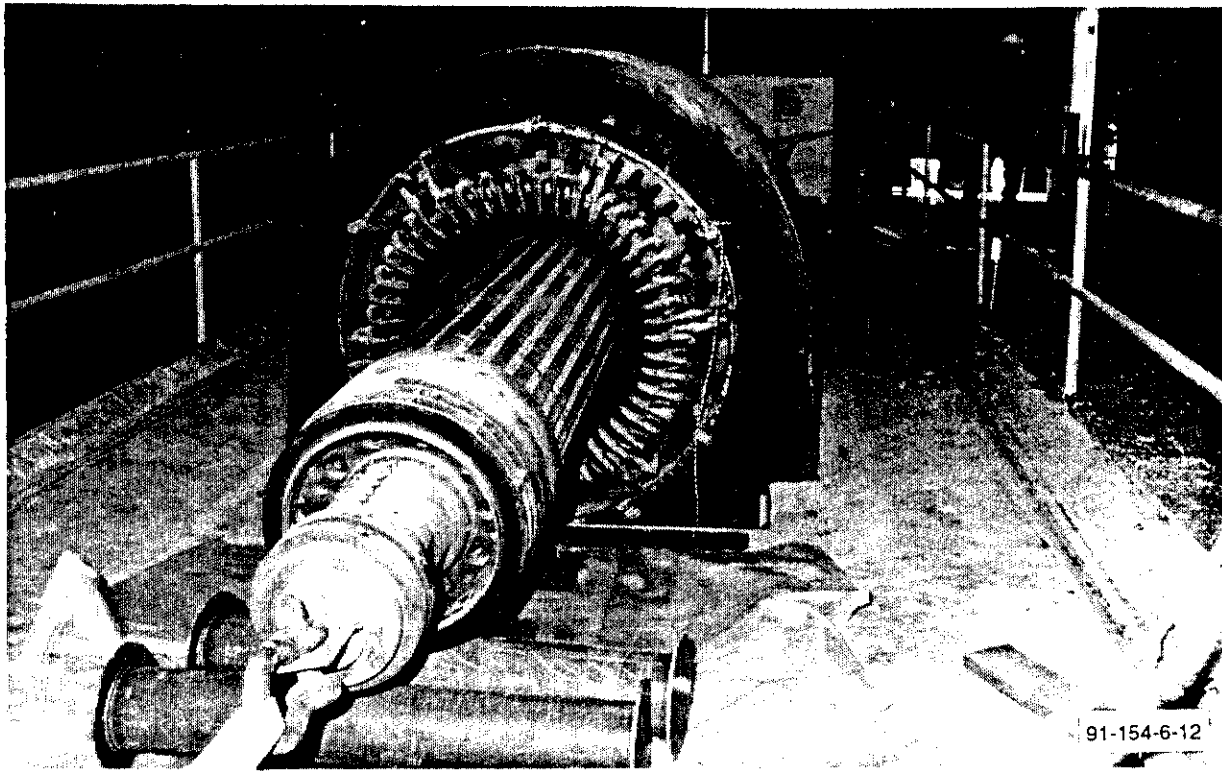
**Figure 18.** Removal of the generator rotor from the stator.

**Turbine-Generator.** The turbine-generator (see Figure 5, Item Number 33) end covers and the exciter were removed during the removal of the steam turbine and transported to the CFA landfill for disposal. The electrical cables were disconnected from the generator and the rotor was pulled out of the stator (see Figure 18) to facilitate lifting of the of the two assemblies through the opening in roof of the turbine building. The stator was unbolted from the floor and broken free of the concrete by driving metal wedges between the bottom of the stator and the I-beams of the support structure. A lift fixture that was specifically designed for lifting the stator was used to lift the assembly through the roof of the building and place it on the transport vehicle. The stator (see Figure 19) and the rotor were wrapped in two layers of contamination control plastic and transported to RWMC for burial. The lift fixture could not be remotely disconnected from the stator so it also was buried at RWMC.

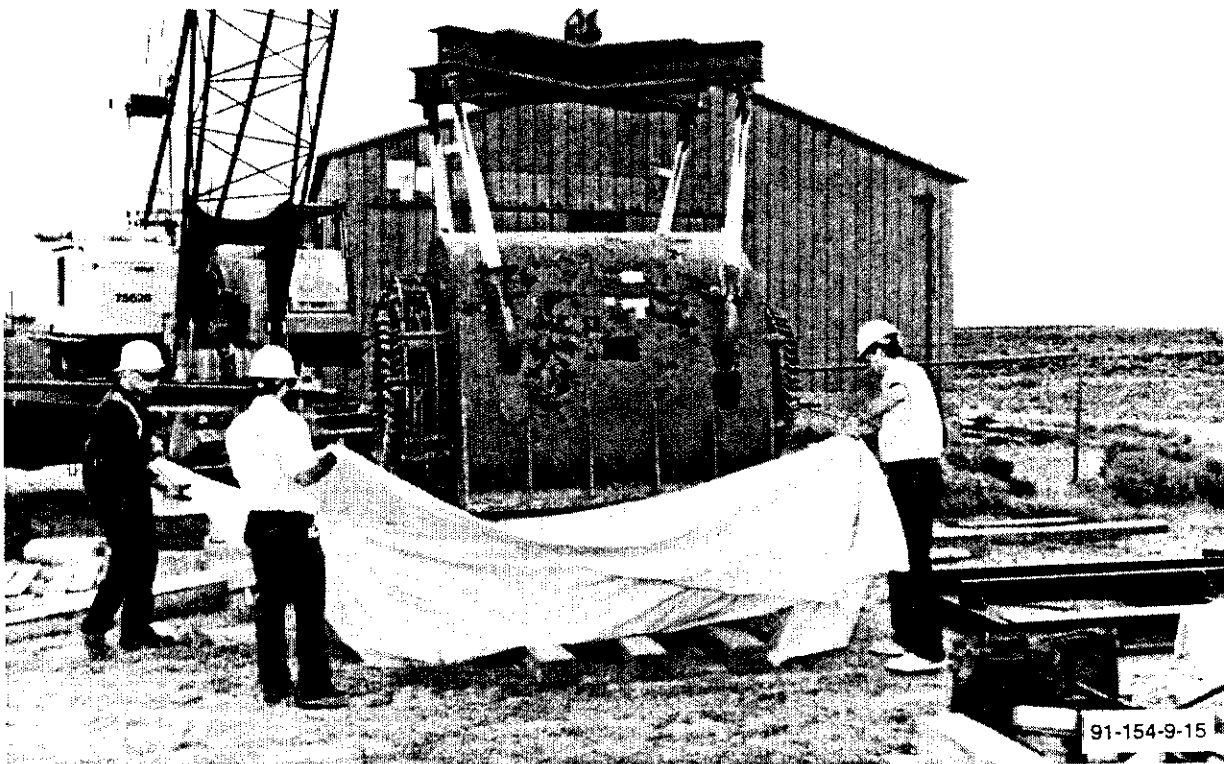
**Figure 19.** Preparation of the generator stator for shipment to RWMC.

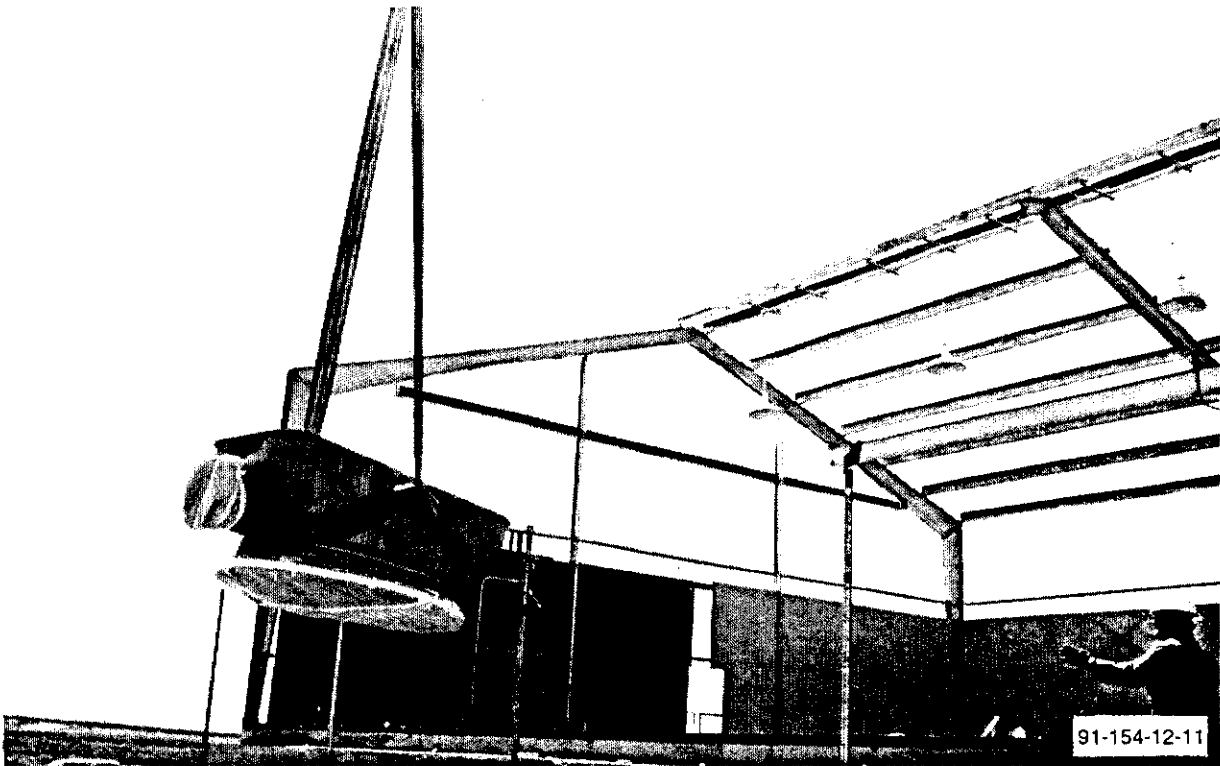
**Figure 20.** Removal of the upper section of the condenser vessel from turbine building.

**Condenser Vessel.** The condenser vessel (see Figure 5, Item Number 3) was blocked up using 4 × 6-in. timbers to prevent it from settling or moving during removal of the turbine assembly and piping that was connected to the vessel. The top section of the condenser vessel (see Figure 20) was unbolted and removed from the main vessel to reduce weight and facilitate handling of the vessel during removal operations. The top section of the condenser vessel was lifted out of the building and is being stored at the reactor building. This section of the condenser vessel will be sent to WERF for sizing to reduce waste volume and ultimately buried at RWMC. Openings in the condenser vessel were closed with plywood and caulking. The main portion of the condenser vessel was lifted out through the south wall of the turbine building (see Figure 21) and placed on a transport trailer. The vessel was wrapped in two layers of contamination control plastic and transported to RWMC for burial.

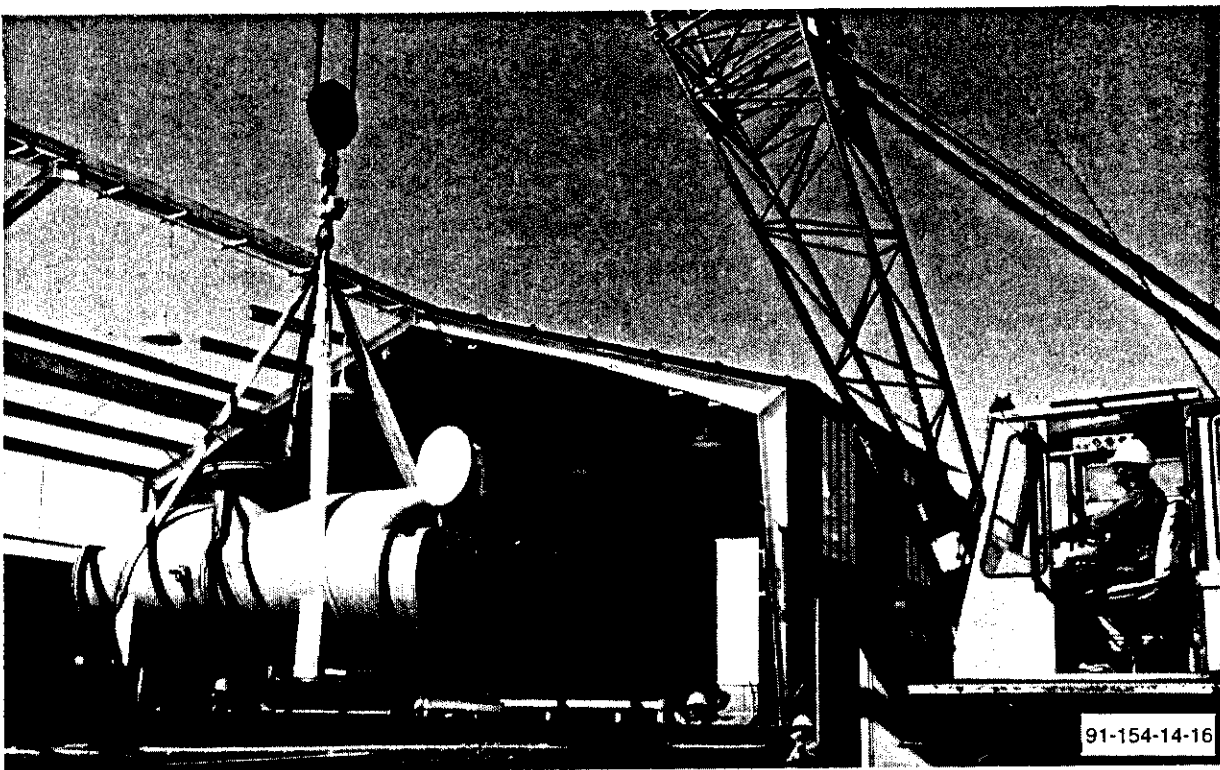
**Figure 21.** Removal of the 15-ton condenser vessel from turbine building.

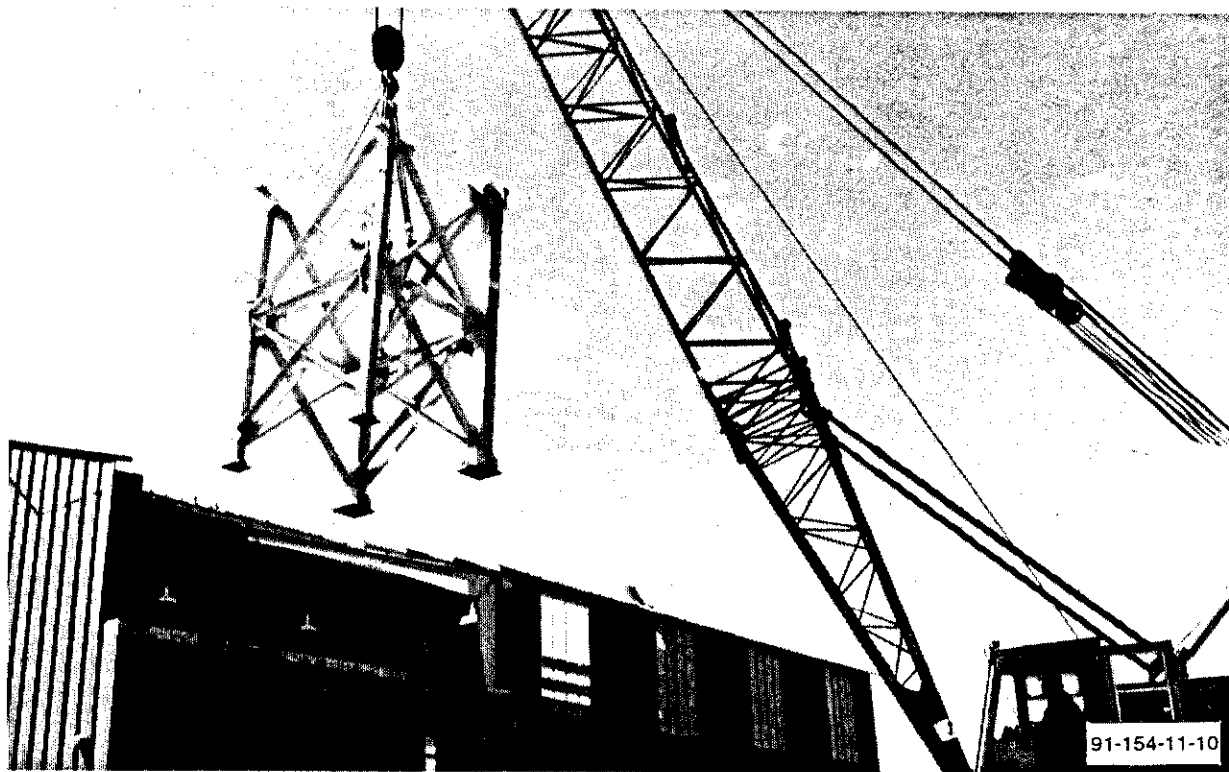
**Figure 22.** Removal of a section of the turbine-generator steel support structure from the turbine building.

**Turbine-Generator Support Structure.** Jackhammers were used to break up the 4- to 6-in. uncontaminated concrete slab poured on the top of the support structure steel substructure. The concrete was boxed and removed from the building basement to be used later for fill material during the demolition and backfill of the basement. The support structure steel I-beams were cut with acetylene torches into manageable sizes and removed from the turbine building with a mobile crane (see Figure 22). The steel from the support structure was transported to the CFA Property Management excess yard for salvage.

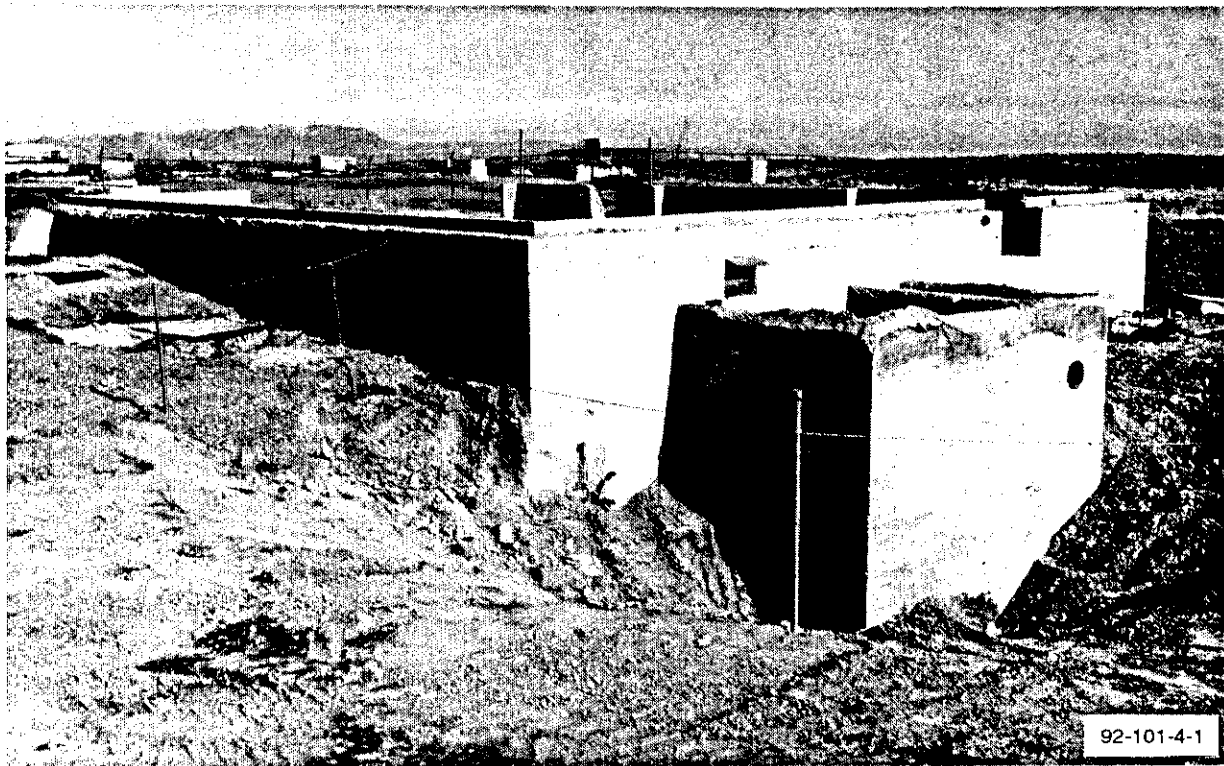
**Figure 25.** View of turbine building foundation prior to demolition and backfill activities.

**Turbine Building Foundation Demolition.** Radiological surveys were performed on the interior and exterior of the building foundation upon completion of the equipment removal operations. Figures 25 and 26 provide views of the turbine building foundation and basement prior to demolition. The areas found to have fixed contamination above releasable limits were decontaminated using surface intrusion methods such as chipping and use of an air-driven needle gun.

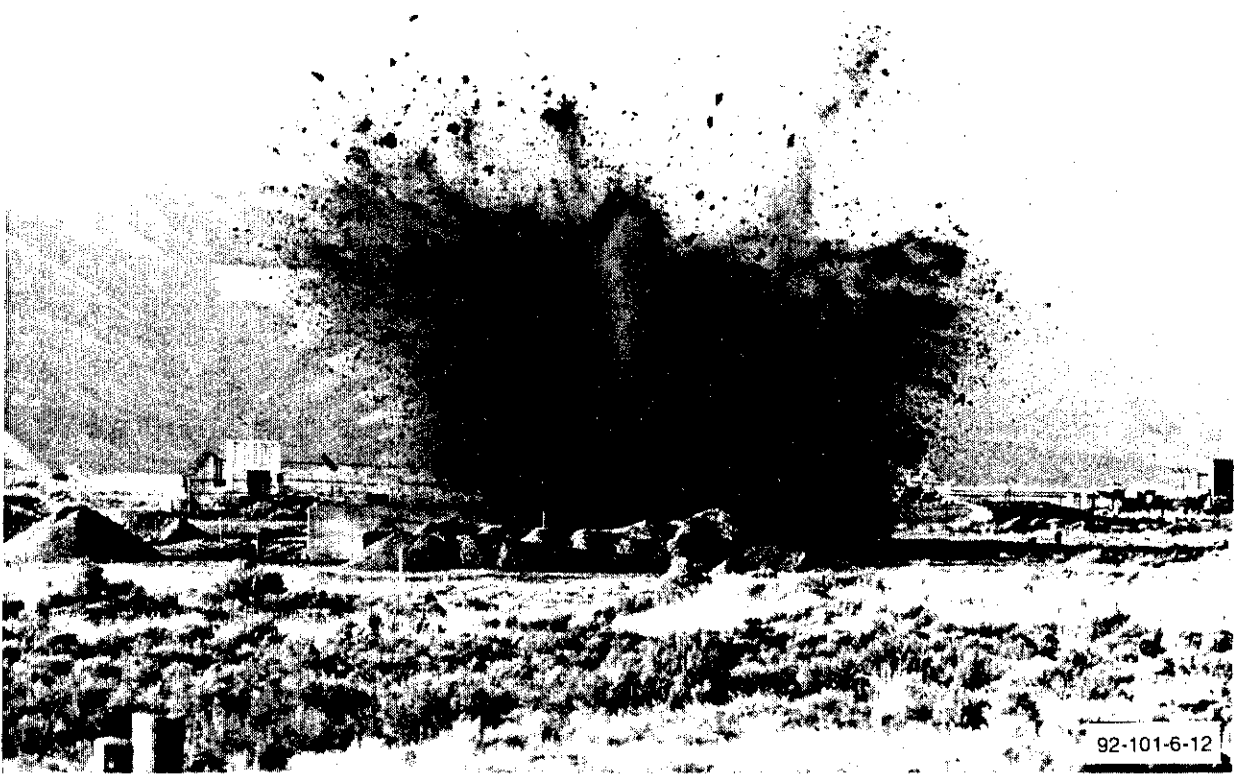
**Figure 27.** View of demolition of turbine building east wall.

Upon receipt of the verification statement for the turbine building<sup>17</sup> from the Independent Verification Contractor (IVC), demolition of the concrete foundation with explosives to 6 ft below grade was performed using an approved demolition plan.<sup>18</sup> The method of demolition followed techniques previously used at the INEL which provided safe and inexpensive demolition of concrete foundations. Welders cut rebar that did not shear from the detonations and a bulldozer was used to push larger sections of the broken concrete into the basement of the building for burial.

Figures 27 through 31 provide views of the turbine building foundation during the demolition activities.

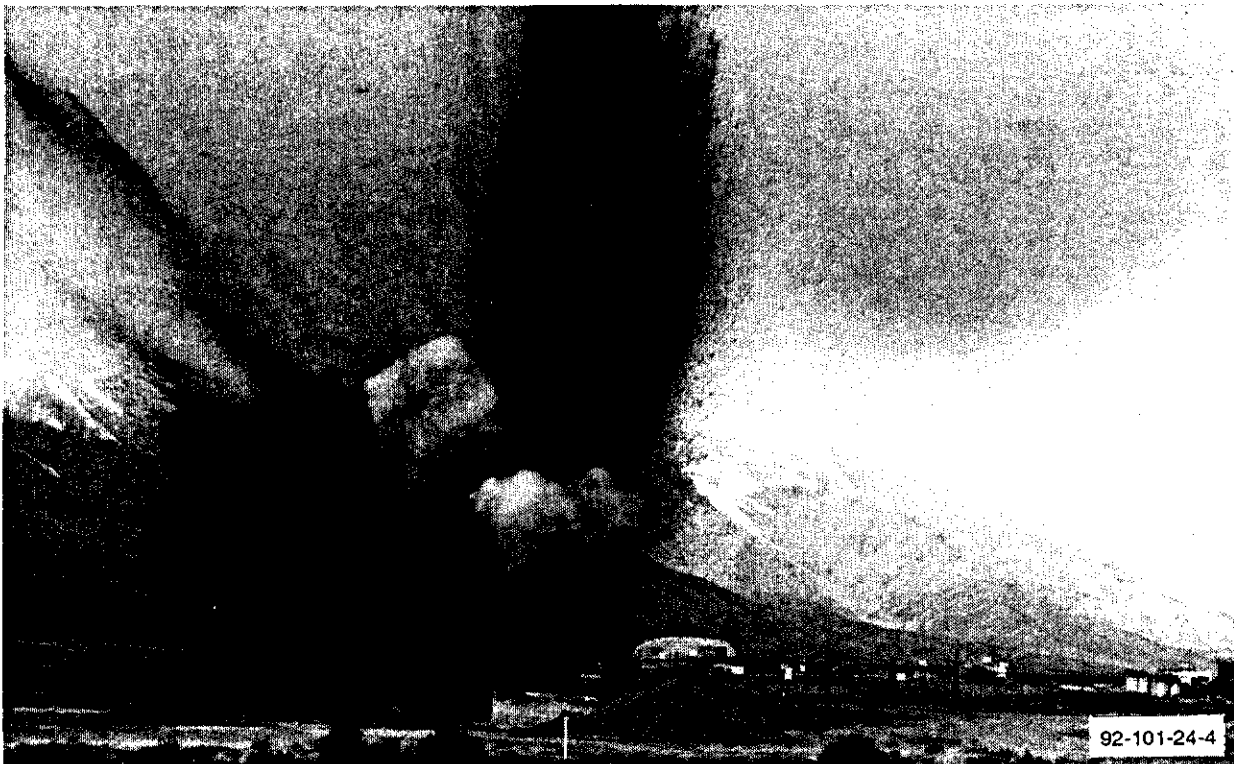
**Figure 28.** View of demolition of turbine building west wall.

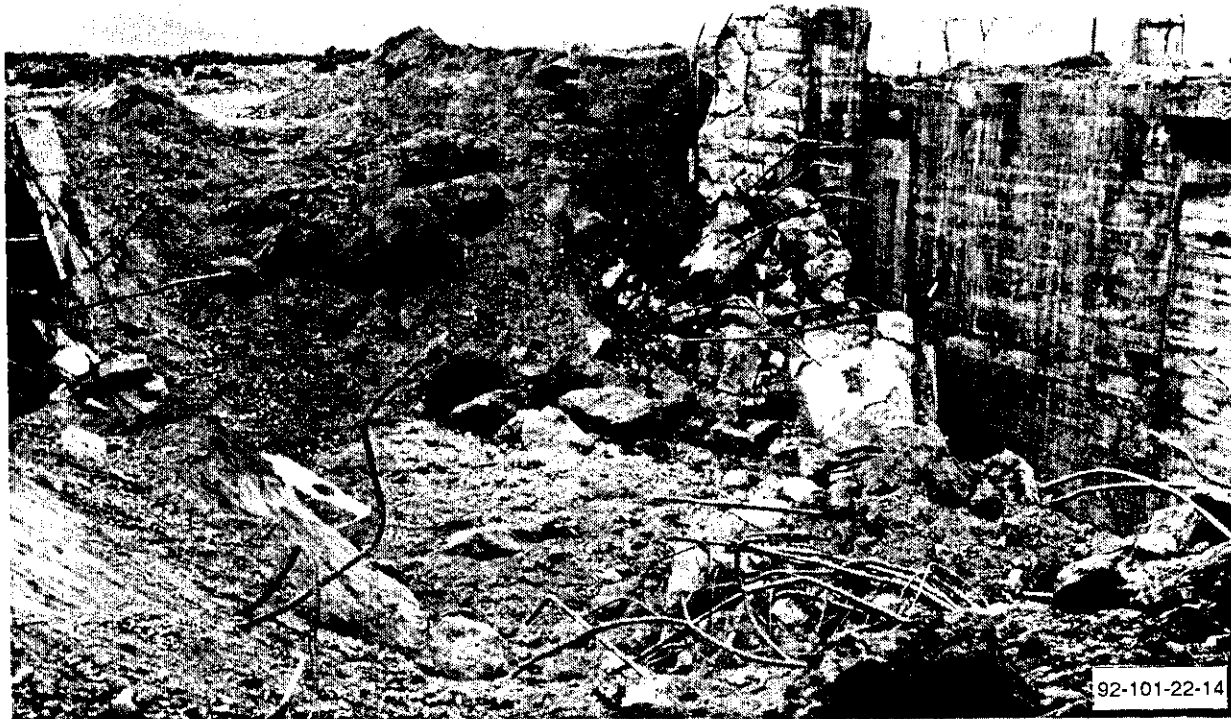
**Figure 29.** View of turbine building foundation after demolition of east, west, and south walls.

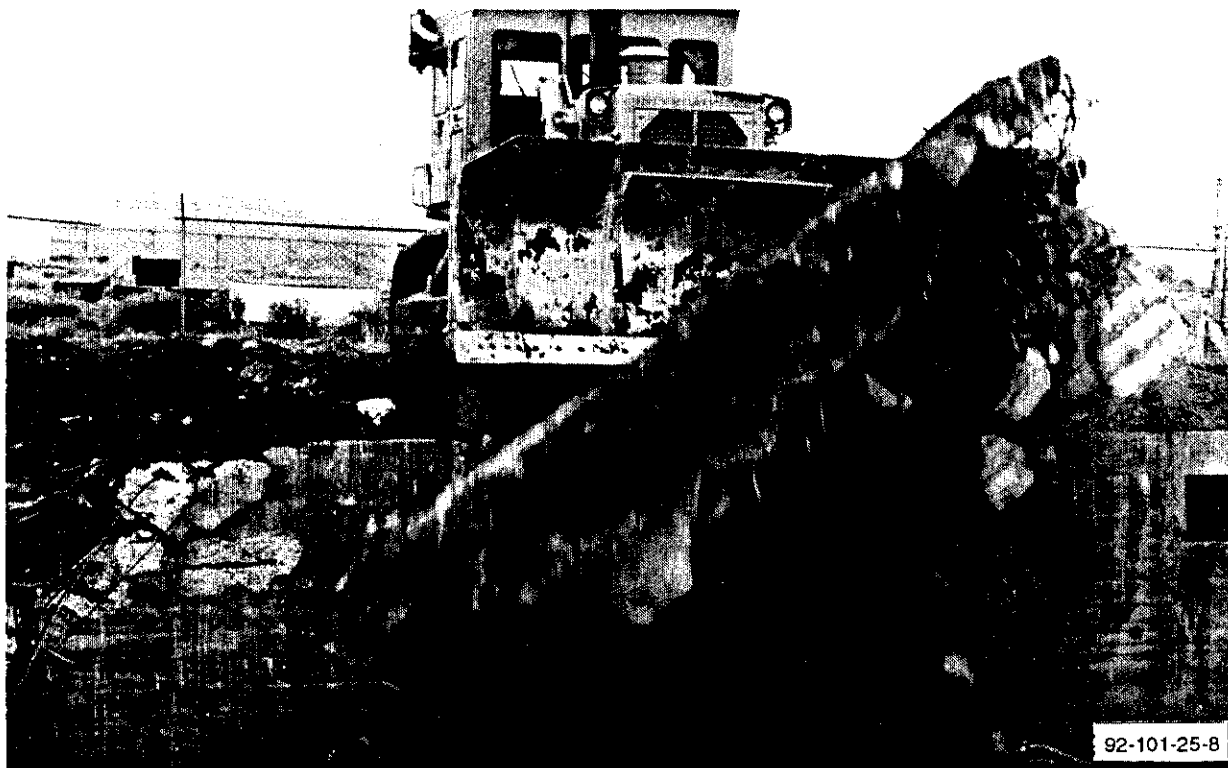
**Figure 30.** View of bulldozer completing breakup of turbine building main floor concrete.

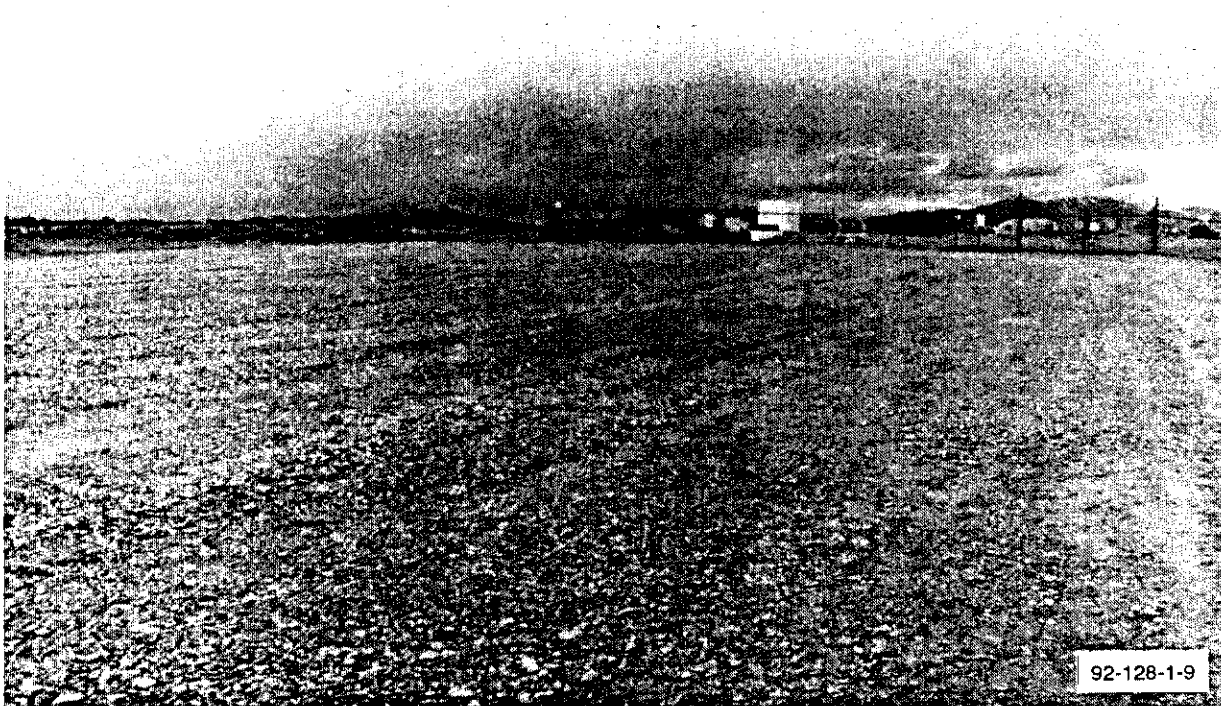
**Figure 32.** View of turbine building site at completion of backfilling and contouring.

**Turbine Building Foundation Backfill.** Fill material was transported to the BORAX-V site from a pit approximately two miles north of the facility. A front-end loader was used to push the fill material into the basement and craters left by the detonations. A grader was used to contour the building foundation area to match the surrounding area. Figure 32 shows the turbine building area at completion of the backfill activities.

The post-decommissioning physical condition of the turbine building site is shown in Figure 32. The area disturbed during the D&D operations has been backfilled and graded to blend with the natural contours of the area. The area will be seeded with native grass and a permanent concrete marker, bearing an inscribed brass plate that identifies the site, will be placed at the approximate center of the former turbine building loca-
